# Polymer Cutout Evaluation

Frank C. Lambert  
Georgia Tech / NEETRAC

High Voltage Fuses Subcommittee  
Calgary, Alberta  
October 14, 2008

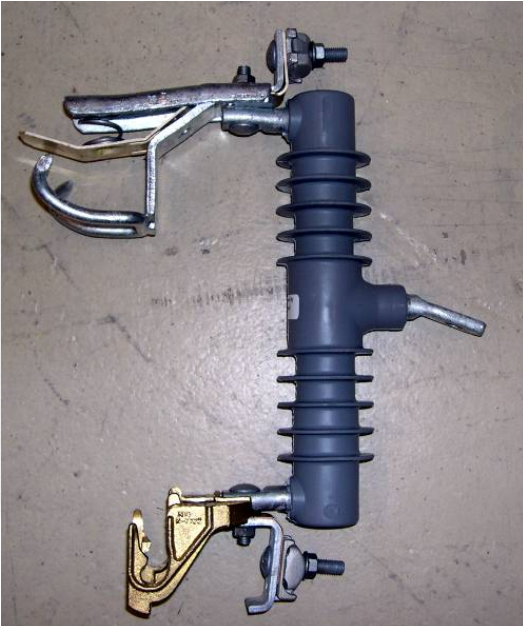
S&C Electric Company

Model: 89021R10-PD

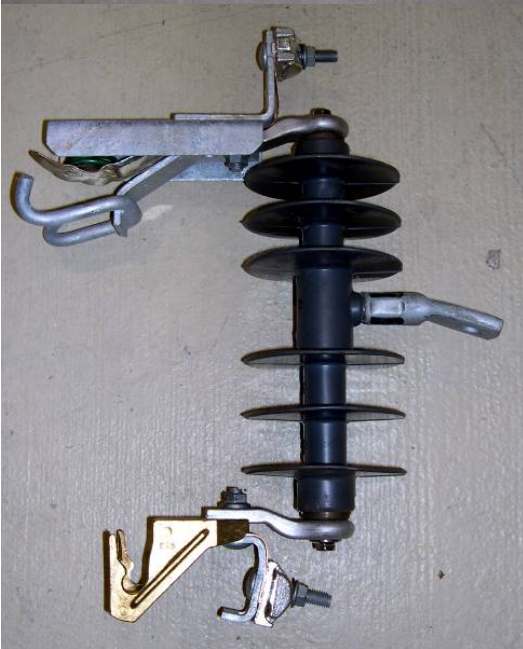
Hubbell Power Systems

Model: CP710-112PB

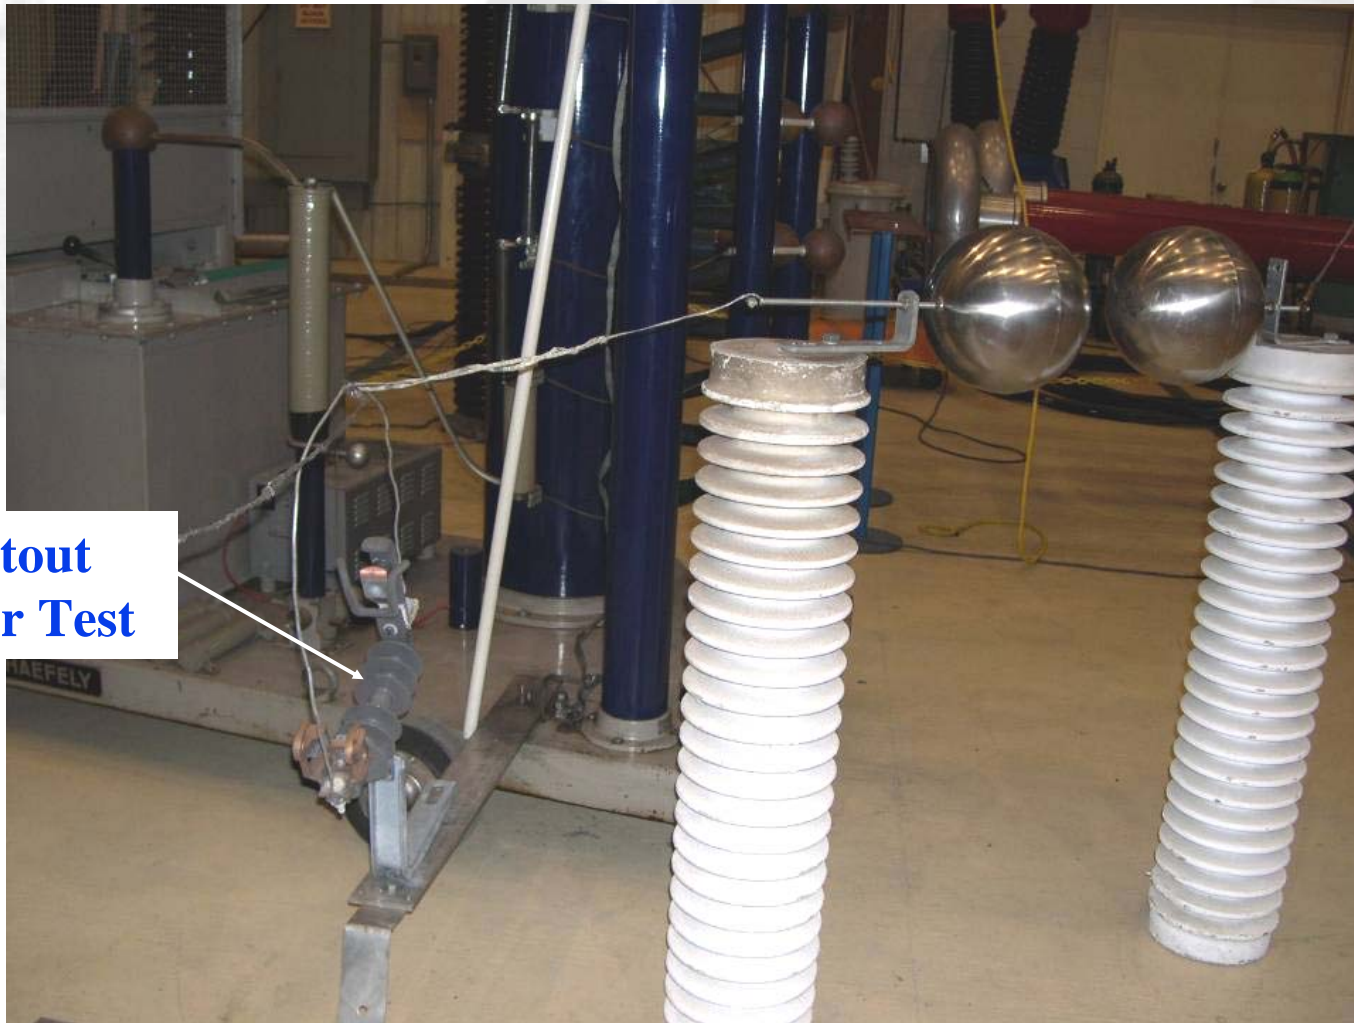
## Steep-front Impulse Voltage Test

**Cutout  
under Test**

- 10 positive and 10 negative impulse waves with a voltage steepness of at least  $1000 \text{ kV}/\mu\text{s}$  per IEEE Std 4-1995, Section 7.2.7.
- The test is considered successful if all impulse applications result in an external flashover of the insulator samples and **NO PUNCTURES** are observed.
